TRANSPORTATION RESEARCH CENTER

ON-SITE AIR BAG INVESTIGATION

CASE NO. - 96-18
FLEET - PRIVATE VEHICLE
LOCATION - CASE ACCIDENT DATE - 1996

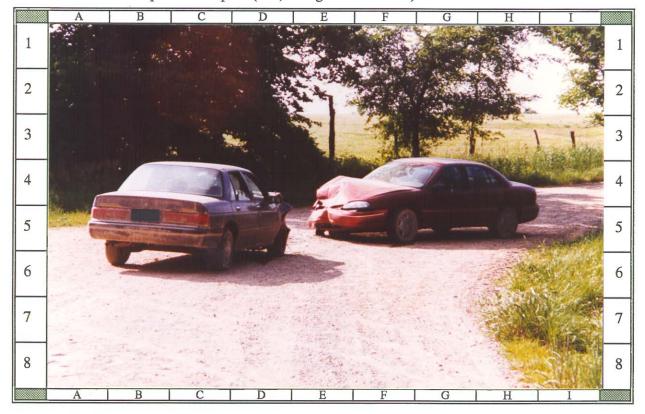
14: On-scene northwestward view of Vehicle #2 (foreground) and Case Vehicle (background) at final rest; NOTE: both drivers steered toward outside of curve

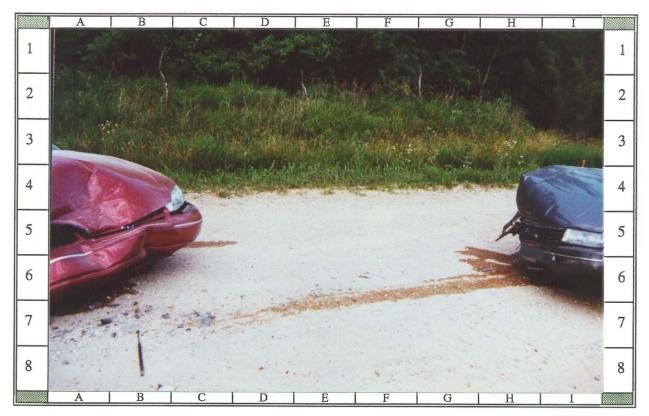
15: On-scene eastward view of Case Vehicle (left) and Vehicle #2 (right) at final rest; NOTE: Vehicle #2 was knocked back from point of impact

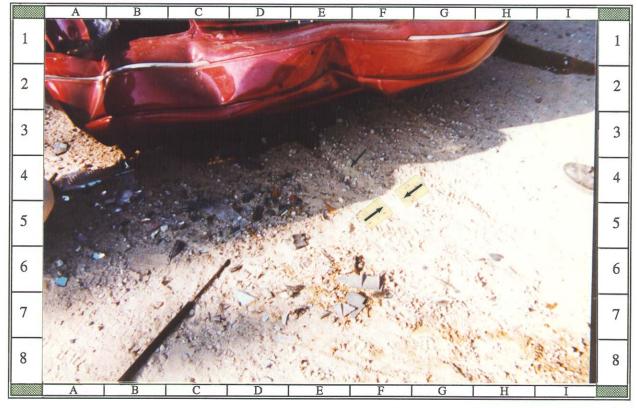
16: On-scene close-up at point of impact of debris in roadway from both vehicles; NOTE: gouge to ground from Case Vehicle's undercarriage (cells F5--E3)

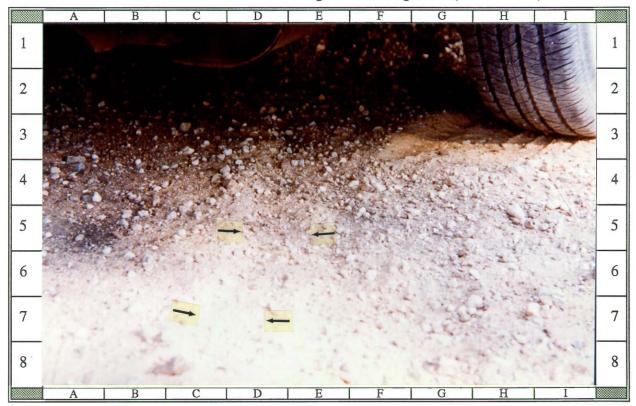
18: On-scene southeastward close-up view of braking mark on gravel roadway from Case Vehicle's left front tire (cells C7-E1) viewed from behind right rear tire

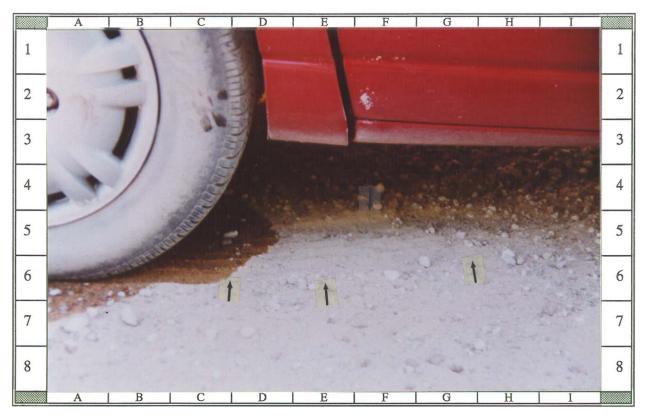
19: On-scene westward close-up of braking mark from Case Vehicle's left front tire of (cells B6-I5); NOTE: Case Vehicle equipped with anti-lock braking system

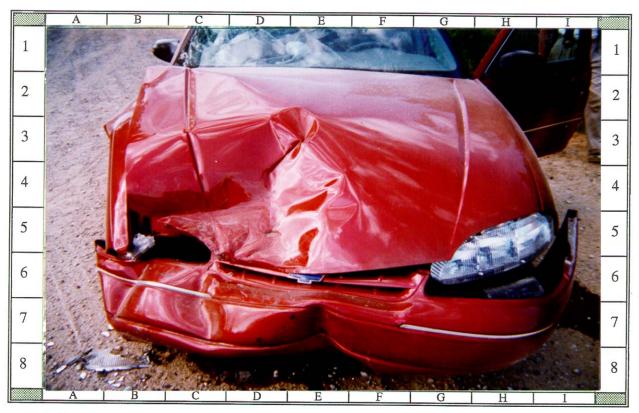
21: On-scene northward view of Case Vehicle's damaged front right; NOTE: direct damage begins near manufacturer's logo (cell E6)

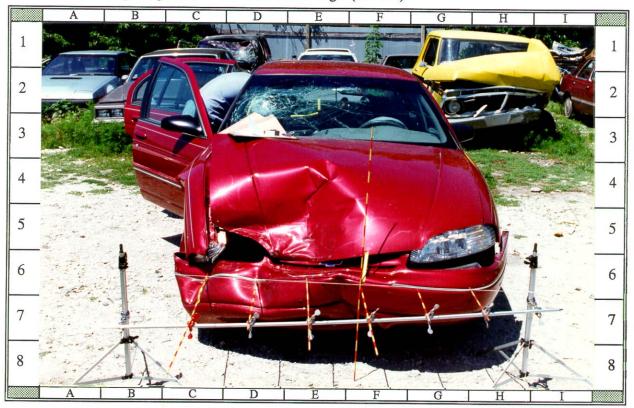
22: Case Vehicle's damaged front end with contour gauge present; NOTE: yellow tape at C_3 marks beginning of direct damage

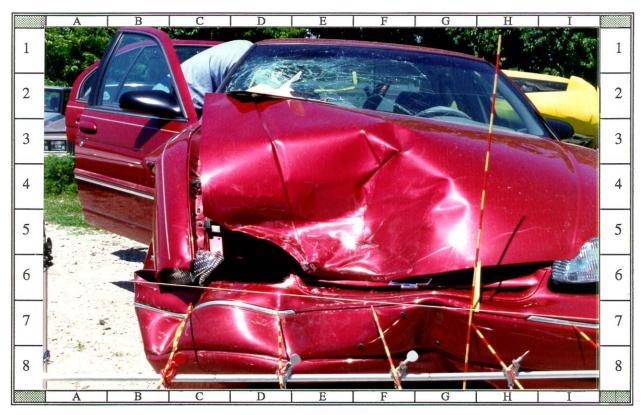
23: Close-up of direct damage to Case Vehicle's front right with contour gauge present; NOTE: underride type damage toward front right corner

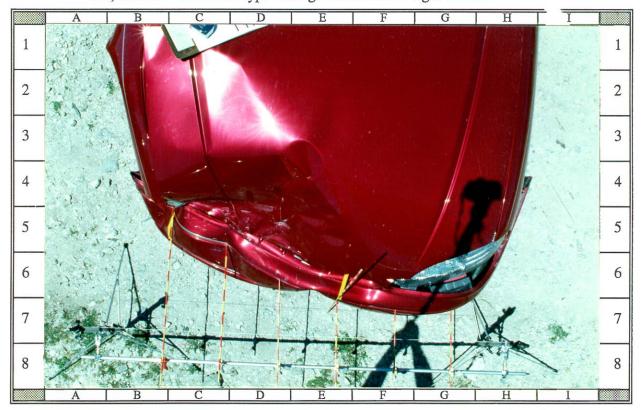
24: Overhead view Case Vehicle's frontal damaged showing crush envelope and maximum crush at C₆

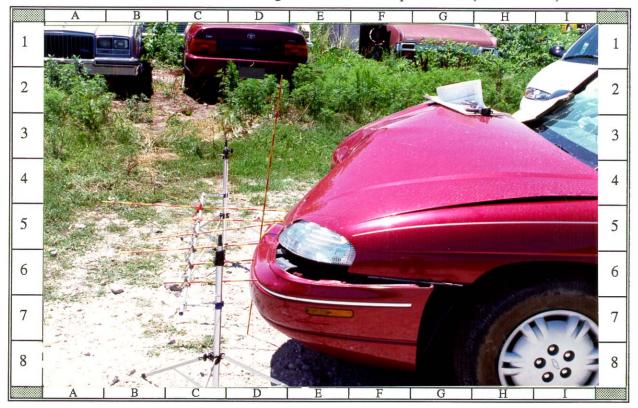
26: Reference line view of Case Vehicle's frontal damage from left with contour gauge present; NOTE: induced damage to left front bumper corner

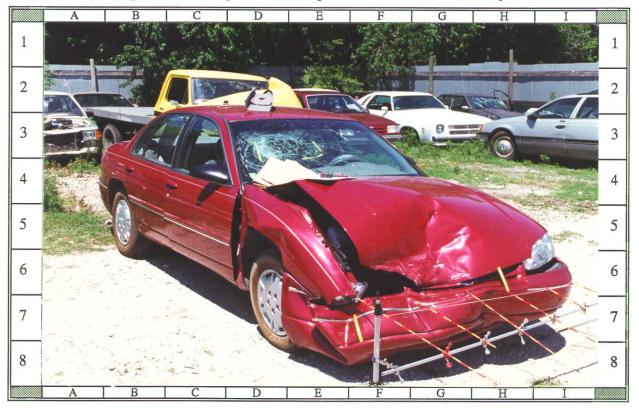
30: Case Vehicle's damaged front viewed from approximately 45 degrees right of front; NOTE: bumper shifted to right and underride type damage pattern

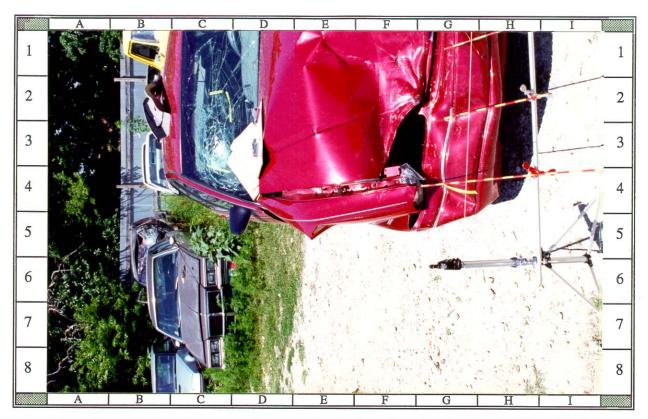
31: Vertical reference line view of Case Vehicle's right side from front showing rightward bumper shift; NOTE: right front windshield damage

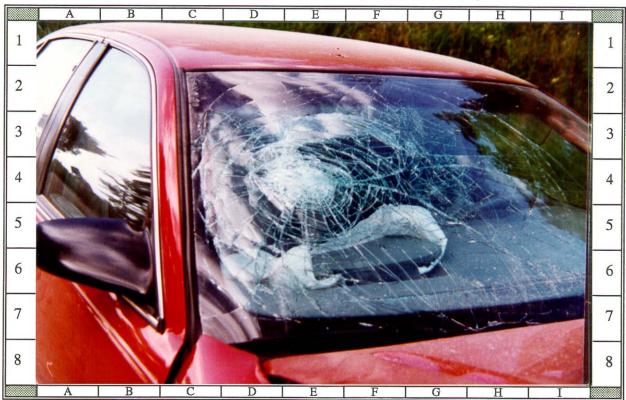
32: On-scene close-up of Case Vehicle's right front windshield damage; NOTE: passenger air bag's cover flap caused damage during deployment

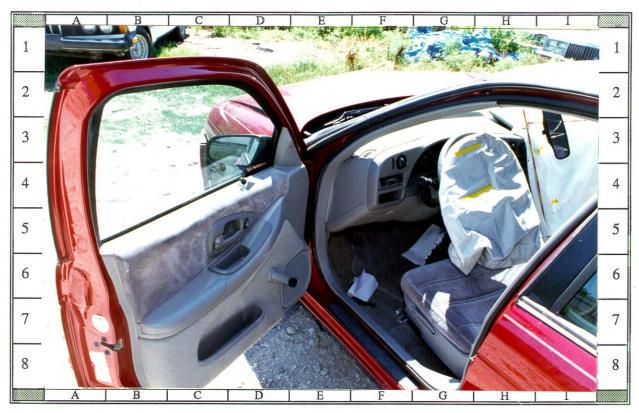
33: Interior surface of Case Vehicle's driver door, seating area, and deployed air bag; NOTE yellow tape indicates contacted area (cells G3--H4)

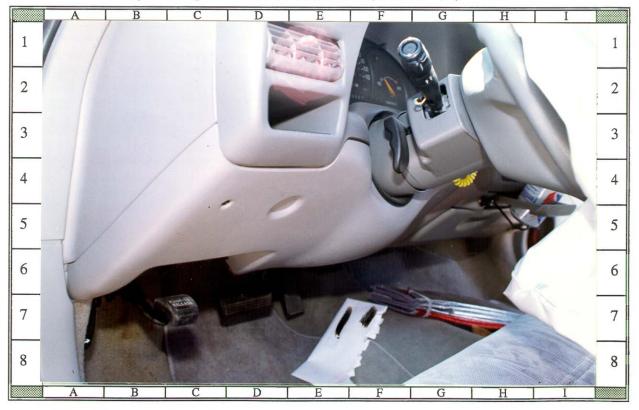
34: Close-up of Case Vehicle's noncontacted driver side knee bolster, steering column, and lower dash

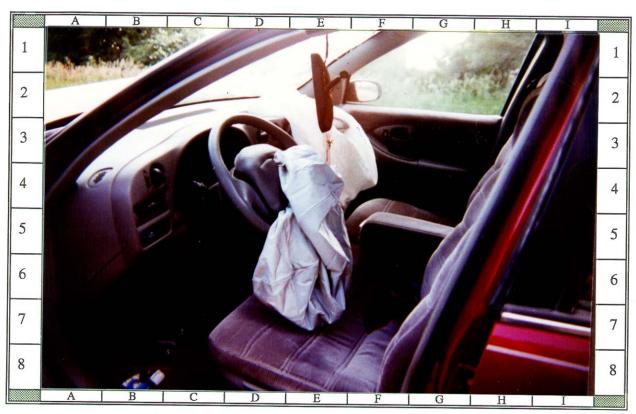
35: On-scene view of Case Vehicle's front seating area showing deployed air bags; NOTE: rear view mirror hanging down

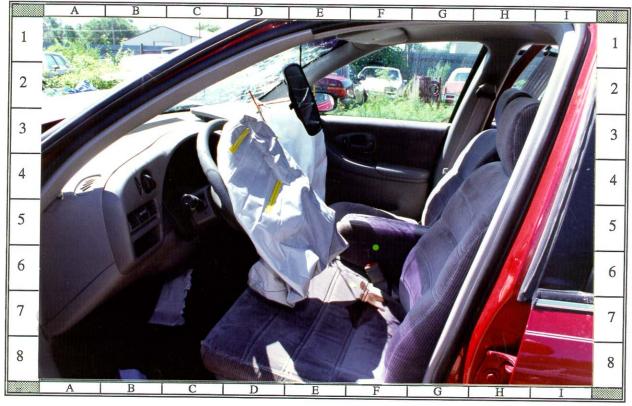
36: Case Vehicle's front seating area showing deployed air bags and damaged rearview mirror; NOTE: contacts highlighted by yellow tape and green dots

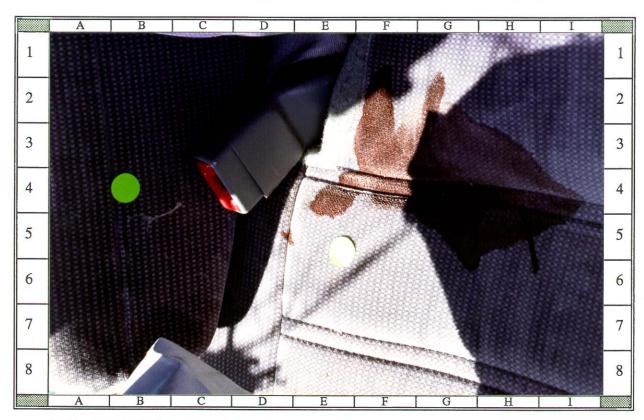
37: Vertical close-up view of mucous on Case Vehicle's center armrest (on driver's side) and blood on driver's seat cushion from right front passenger

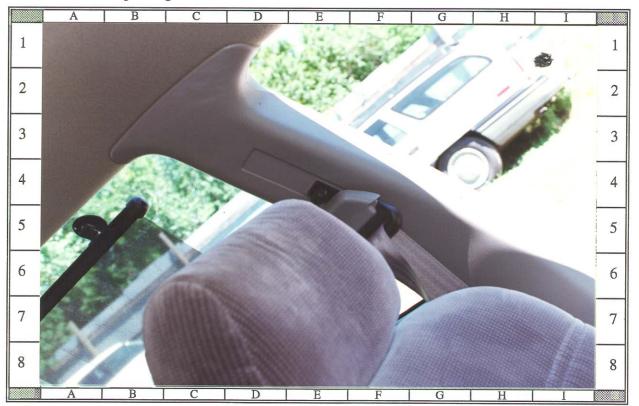
40: Case Vehicle's driver side adjustable shoulder belt anchorage showing anchorage at the full down position

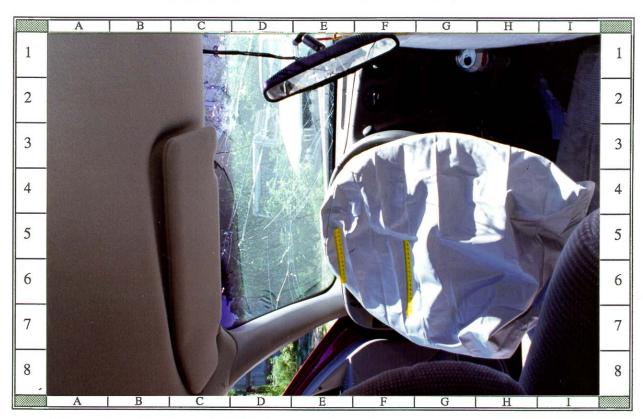
41: Vertical view of Case Vehicle's driver seating area from center rear showing greenhouse and deployed air bag; NOTE: tape highlights contact on air bag

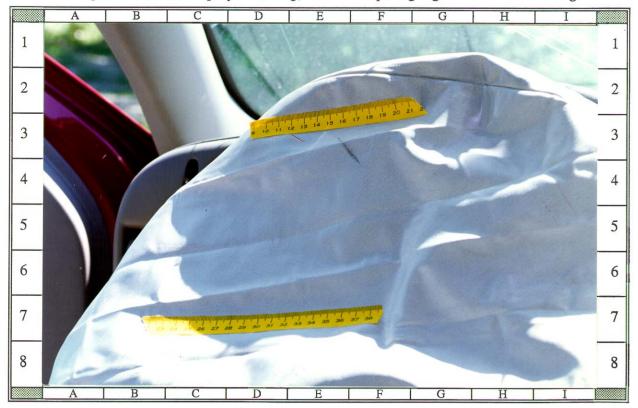
42: Close-up of Case Vehicle's deployed driver side air bag viewed from center showing contact area on air bag between yellow tape

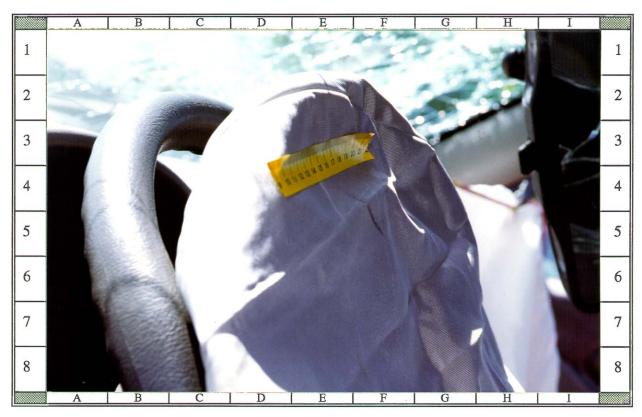
Because of the driver's stature⁸ and her nonuse of the available safety belts, she most likely submarined enough to cause her to contact her left knee on the knee bolster, her right knee on the underside of the steering column, and the bottom rim with her abdomen, all of which she indicated were contused. In addition, it is possible this contact with the steering wheel rim caused the tilt wheel to shift upward were it was found at the time of the vehicle inspection.

43: Closer-up view of top portion of contact area on Case Vehicle's deployed driver air bag (i.e., below yellow tape); NOTE: steering wheel rim is bent at top

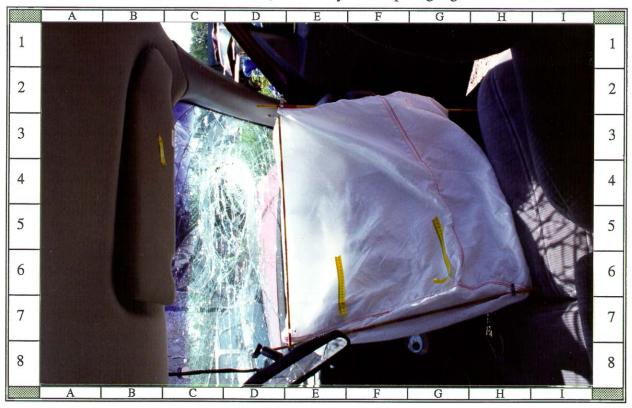
46: Vertical view of Case Vehicle's right front seating area viewed from center rear showing deployed passenger air bag, windshield, and rearview mirror

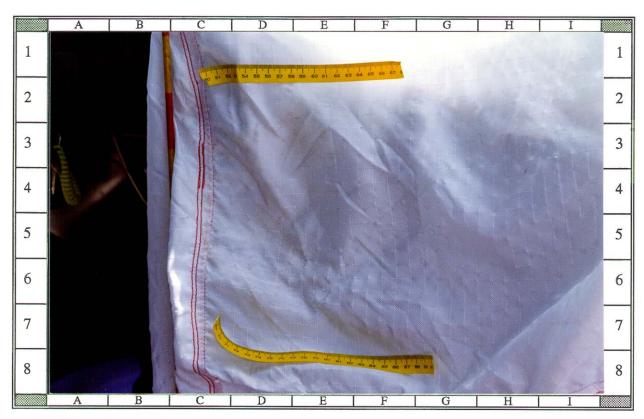
47: Close-up of contact (i.e. skin and oil) area--between yellow tape, on Case Vehicle's right front passenger air bag (cells D2--E6)

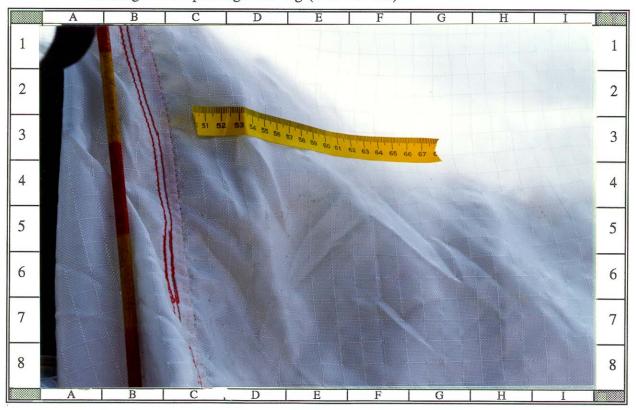
48: Closer-up view of contacts (i.e., skin and oil transfer) to left upper portion of Case Vehicle's deployed right front passenger air bag (cells C7--E4)

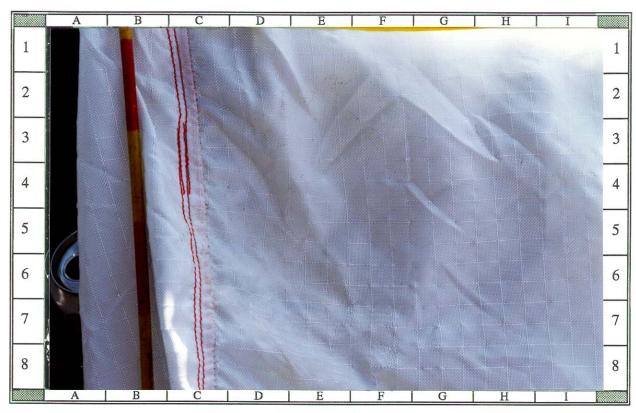
49: Closer-up view of contacts (i.e., skin and oil transfer) to left center portion of Case Vehicle's deployed right front passenger air bag (cells C4--E2)

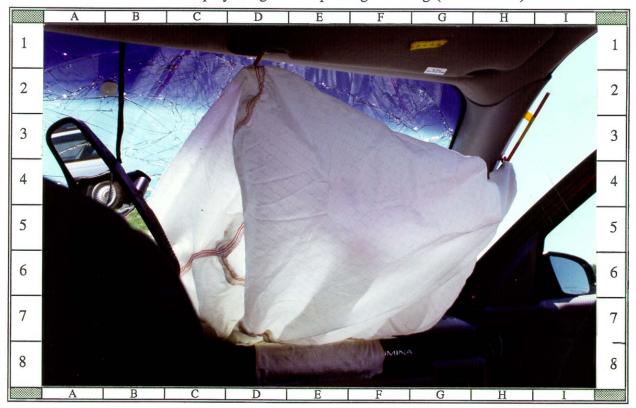
50: Underneath view of Case Vehicle's deployed right front passenger air bag showing no contact evidence; NOTE: tape on sunvisor

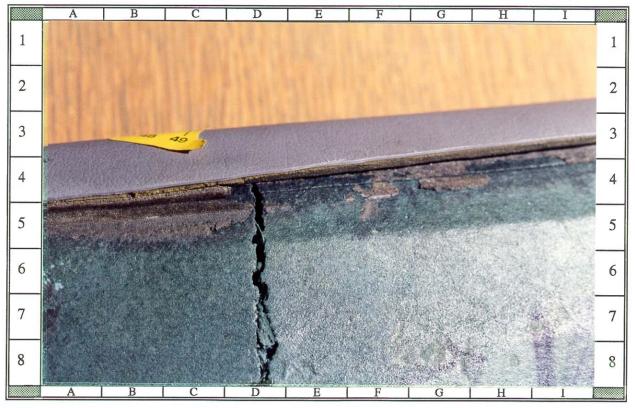
The available physical evidence almost certainly indicates that there was a substantial interaction between the right front air bag module's cover flap and the child because the cover flap was depress (see SELECTED PHOTOGRAPHS #57 and #62) and cracked (see SELECTED PHOTOGRAPHS #59 and #60).

60: Close-up of crack to underside of Case Vehicle's right front air bag module's top cover flap; NOTE: possible contact along lip edge right of crack

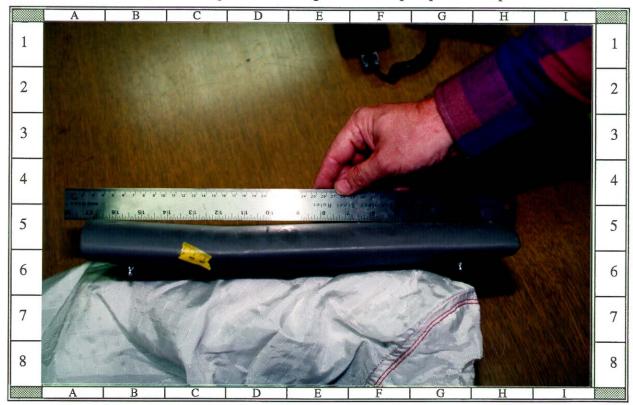
62: Case Vehicle's right front air bag module's top cover flap viewed from straight on showing bowing most likely from contacting right front passenger's lower face

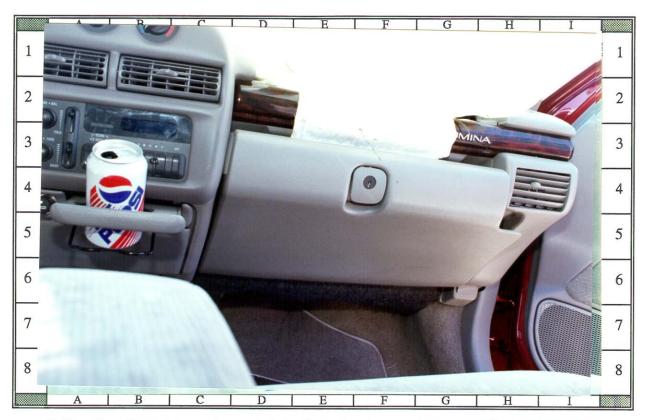
63: Case Vehicle's center and right dash showing partially opened glovebox door; NOTE: can in center holder has been pushed inward

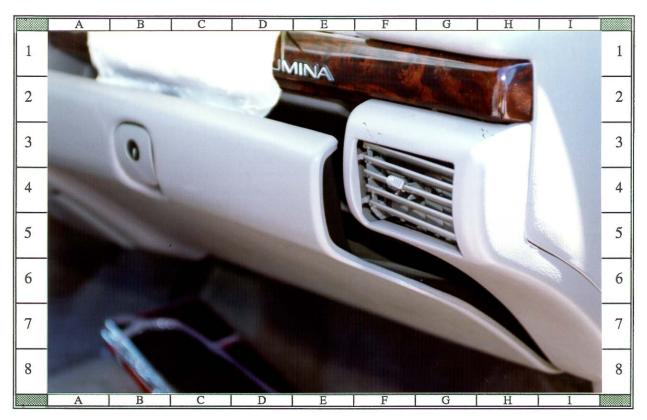
65: Close-up of Case Vehicle's right dash air vent which has been pushed inward (cells F3--F4) most likely from contact with right front passenger

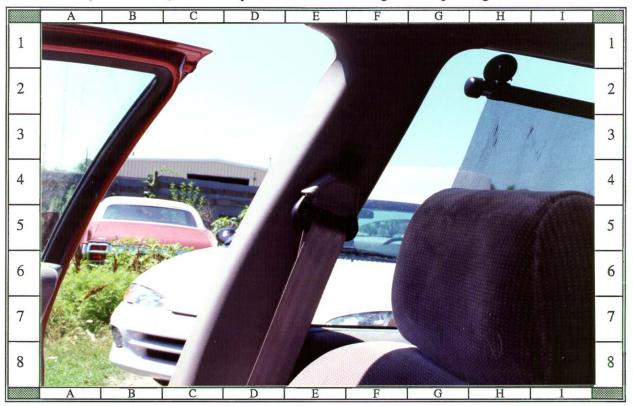
66: Case Vehicle's adjustable right front shoulder belt upper anchorage; NOTE: anchorage adjusted to lowest position

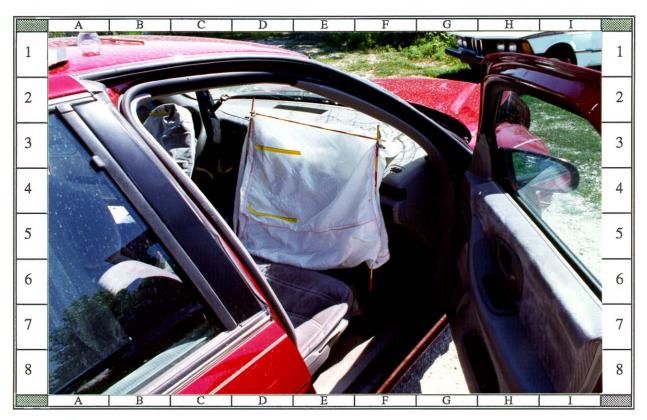
67: Interior surface of Case Vehicle's right front door, seating area, and deployed air bag; NOTE: contact area on air bag

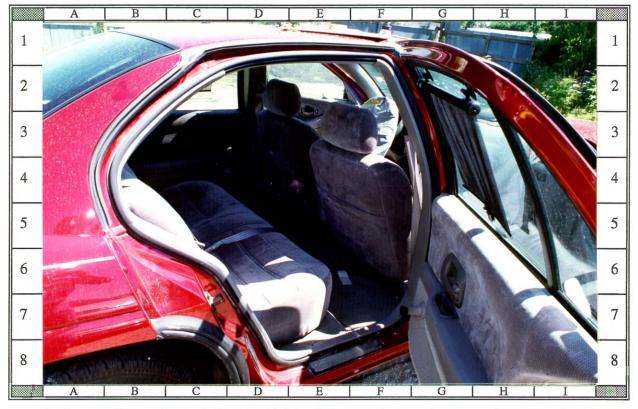
68: Interior surface of Case Vehicle's right rear door and rear seating area viewed from outside door; NOTE: third occupant in right rear seating position

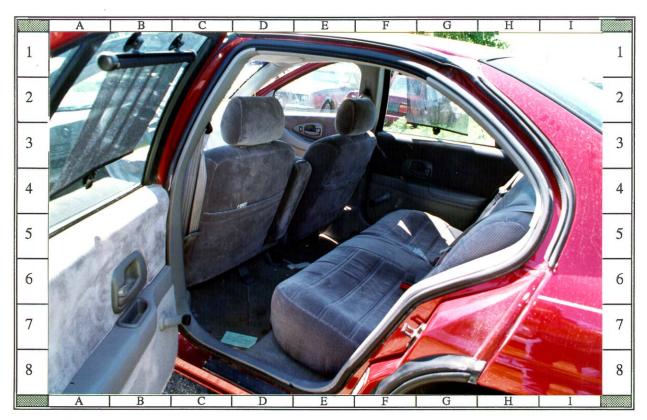
69: Interior surface of Case Vehicle's left rear door and rear seating area viewed from outside door; NOTE: adjustable front head restraints

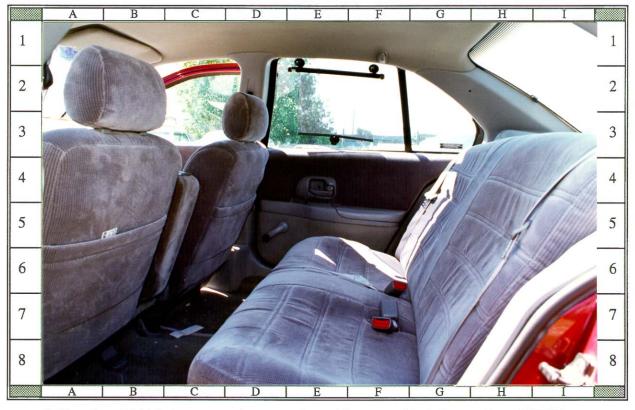
70: Case Vehicle's rear seating area viewed from outside left rear door; NOTE: no contact evidence to right front seatback and three-point restraints in rear

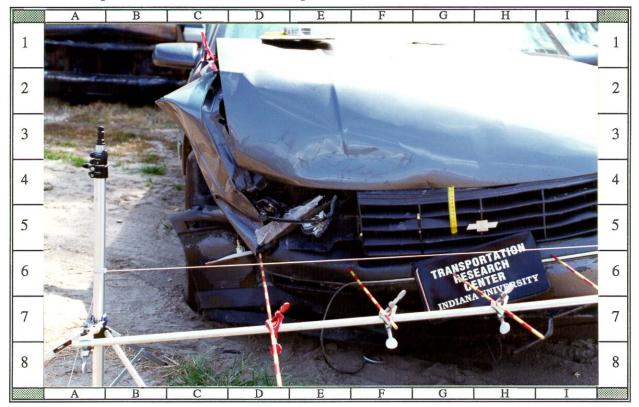
72: Close-up of direct damage to front right of Vehicle #2; NOTE: maximum crush occurs at front right bumper corner C_6

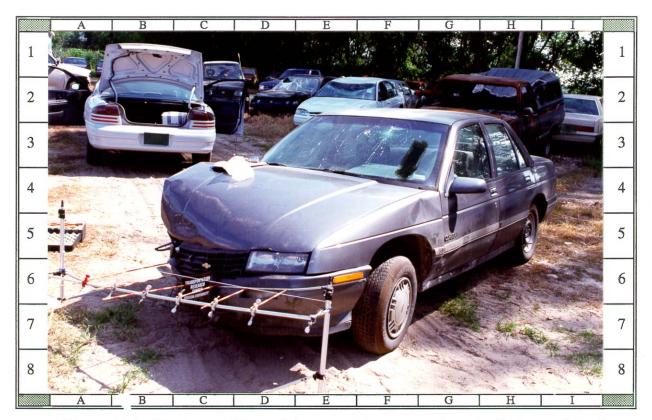
73: Vehicle #2's damaged front right viewed from approximately 45 degrees left of front; NOTE: induced damage to left front fender near door

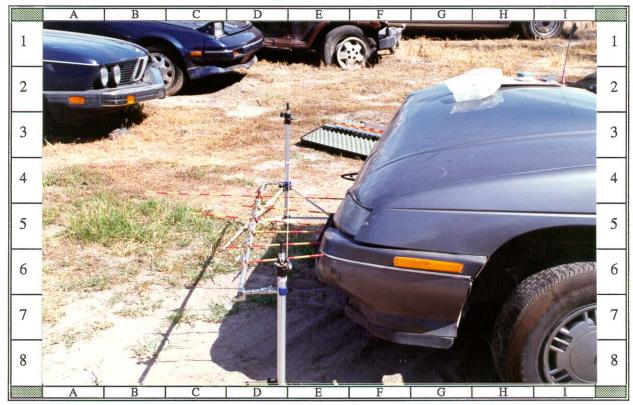
74: Reference line view of Vehicle #2's frontal damage from left with contour gauge present showing depth of crush; NOTE: maximum crush is at C₆

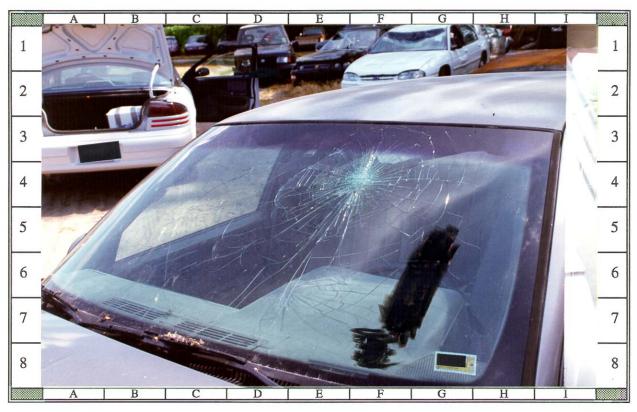
75: Exterior close-up of spiderweb contact on windshield from vehicle #2's driver viewed from approximately 60 degrees front of left

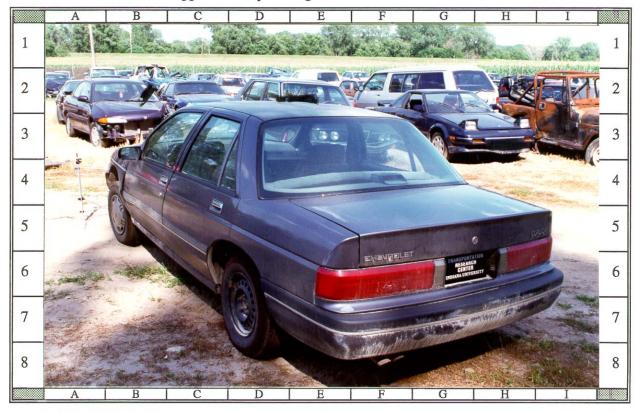
76: Vehicle #2's undamaged back and left side (i.e., behind left front fender) viewed from approximately 30 degrees left of back

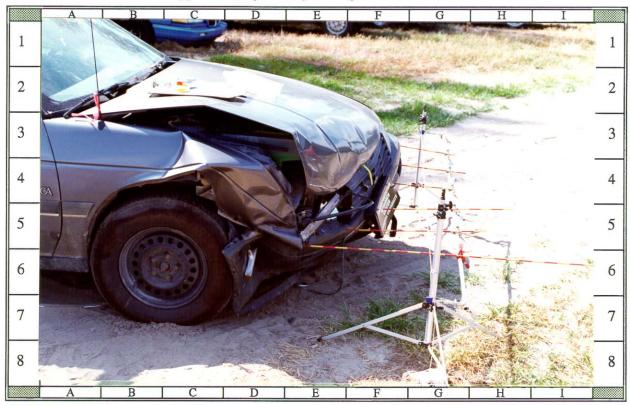
78: Reference line view of Vehicle #2's frontal damage from right; NOTE: right front tire is restricted by sheet metal crush

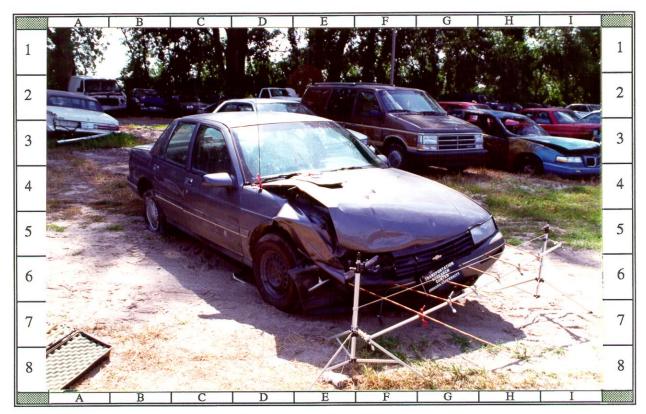
79: Vehicle #2's damaged front right viewed from approximately 45 degrees right of front with contour gauge present

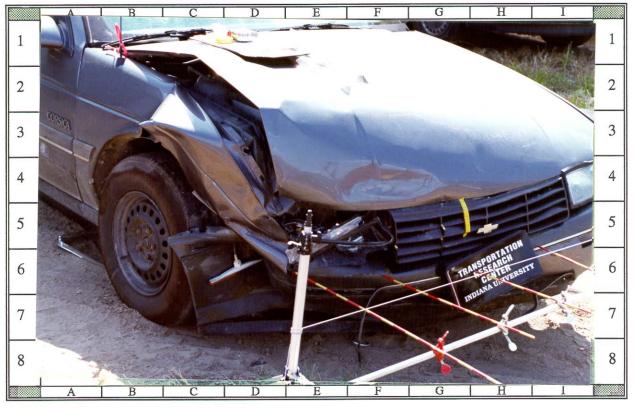
80: Close-up of Vehicle #2's damaged front right viewed from approximately 45 degrees right of front; NOTE: yellow tape indicates end of direct damage

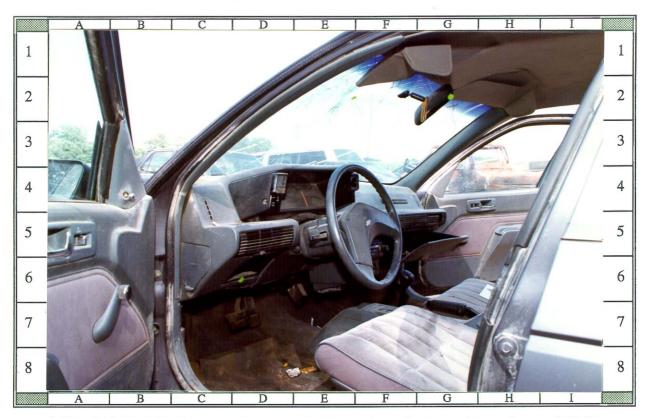
81: Vehicle #2's driver seating area, dash, steering column, and greenhouse; NOTE: contacts to windshield, sunvisor, mirror and left lower dash

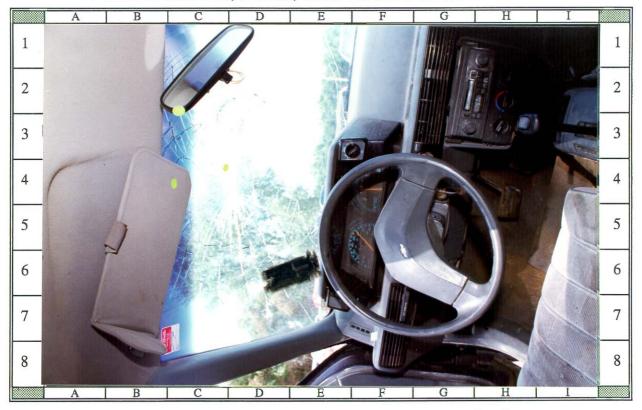
82: Vehicle #2's driver seating area viewed from center rear showing contacts to windshield, sunvisor, and mirror; NOTE: speedometer indicates 60 m.p.h.

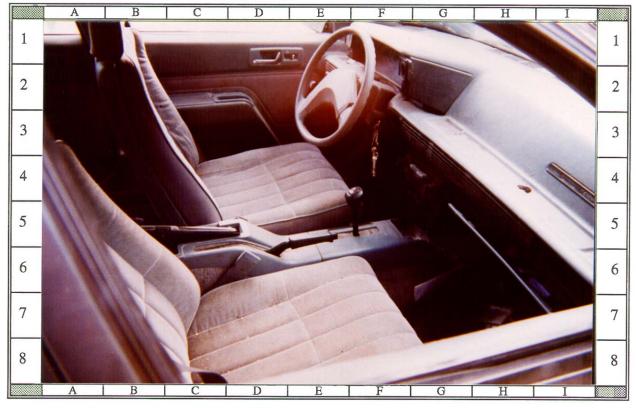
84: On-scene view of Vehicle #2's front seating area showing driver's seat in or close to full forward position; NOTE: steering wheel appears undamaged

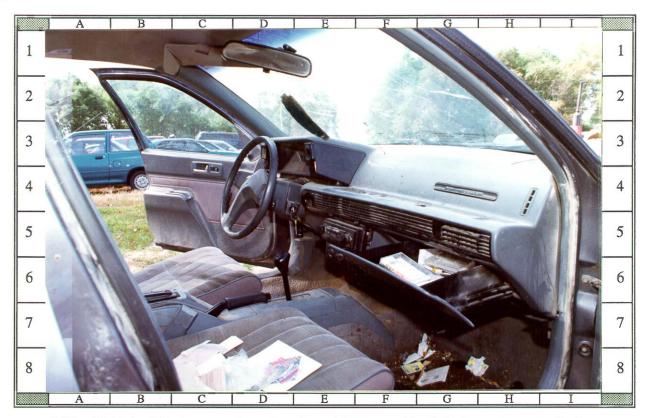
85: Vehicle #2's front seating area viewed from outside right front passenger's door showing glovebox door which was opened post-impact; NOTE: driver's sunvisor

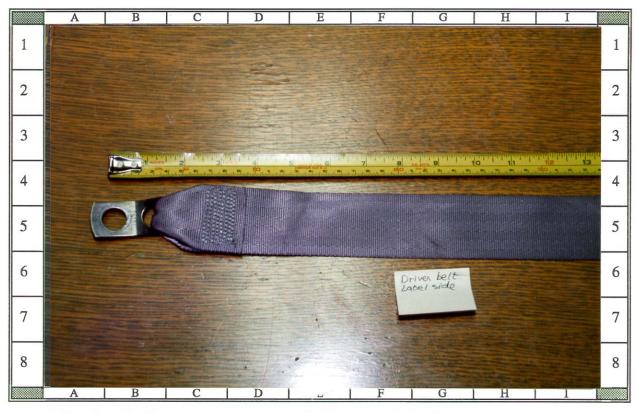
87: Case Vehicle's driver side safety belt (i.e., 1 of 7) showing side toward a restrained driver and left floor anchorage attachment

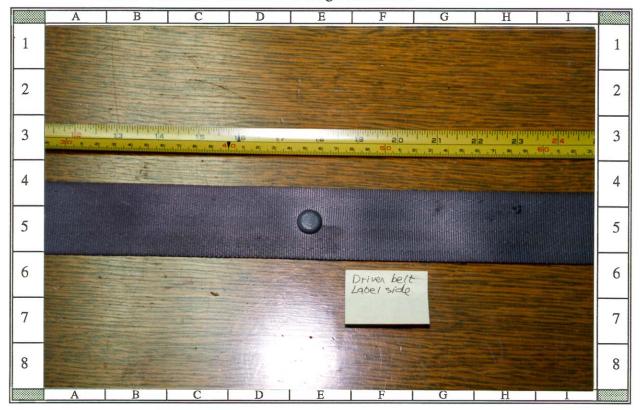
88: Case Vehicle's driver side safety belt (i.e., 2 of 7) showing side toward a restrained driver; NOTE: no evidence of loading

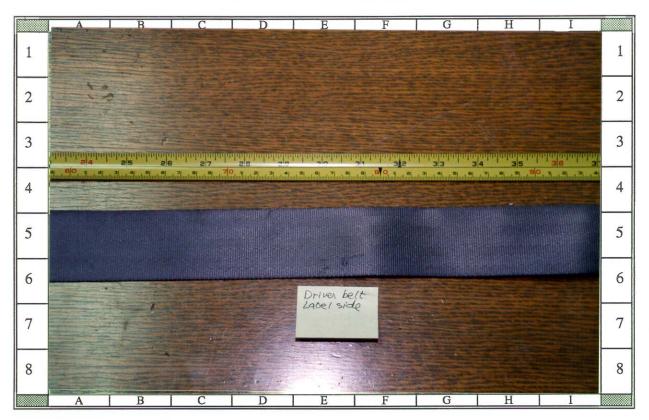
89: Case Vehicle's driver side safety belt (i.e., 3 of 7) showing side toward a restrained driver; NOTE: no evidence of loading

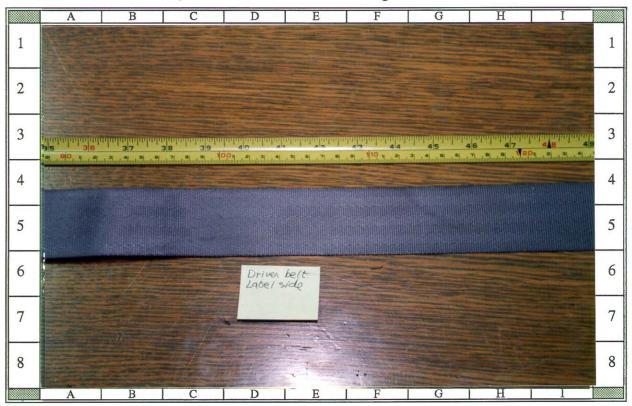
90: Case Vehicle's driver side safety belt (i.e., 4 of 7) showing side toward a restrained driver; NOTE: no evidence of loading

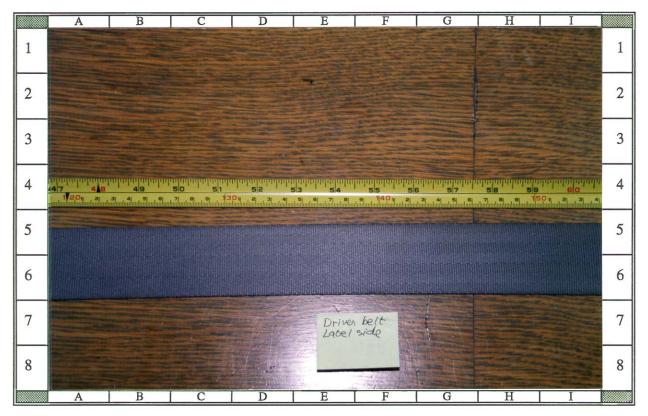
91: Case Vehicle's driver side safety belt (i.e., 5 of 7) showing side toward a restrained driver; NOTE: no evidence of loading

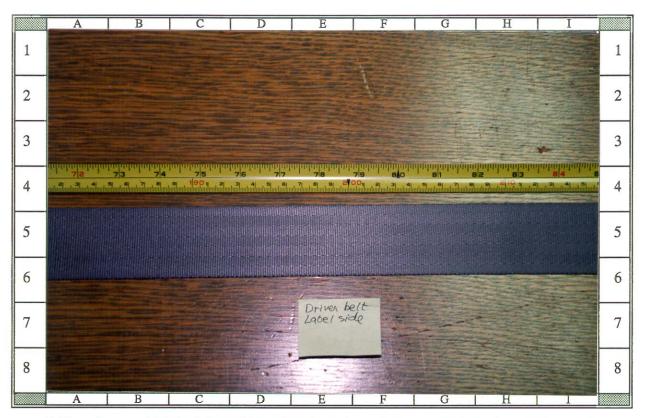
93: Case Vehicle's driver side safety belt (i.e., 7 of 7) showing side toward a restrained driver; NOTE: no evidence of loading

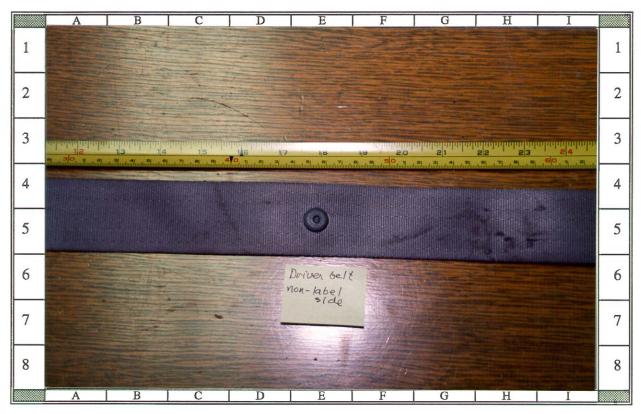
95: Case Vehicle's driver side safety belt (i.e., 2 of 7) showing side away from a restrained driver; NOTE: grease smears but no evidence of loading

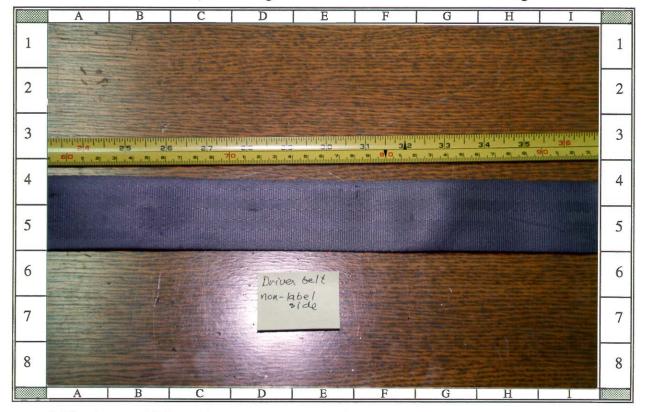
96: Case Vehicle's driver side safety belt (i.e., 3 of 7) showing side away from a restrained driver; NOTE: grease smears but no evidence of loading

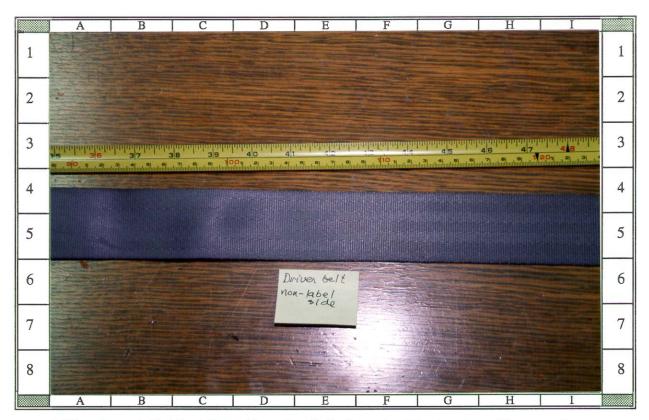
97: Case Vehicle's driver side safety belt (i.e., 4 of 7) showing side away from a restrained driver; NOTE: no evidence of loading

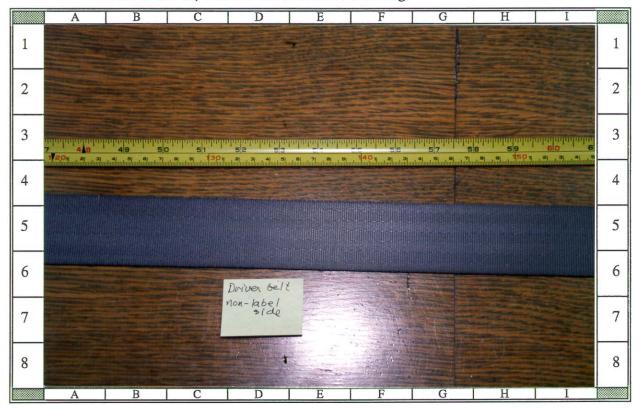
98: Case Vehicle's driver side safety belt (i.e., 5 of 7) showing side away from a restrained driver; NOTE: no evidence of loading

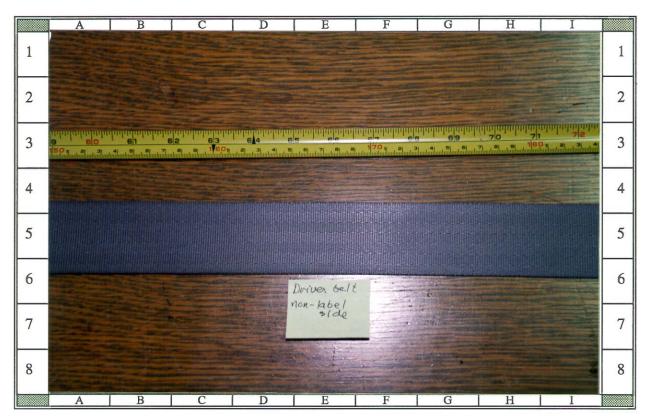
99: Case Vehicle's driver side safety belt (i.e., 6 of 7) showing side away from a restrained driver; NOTE: no evidence of loading

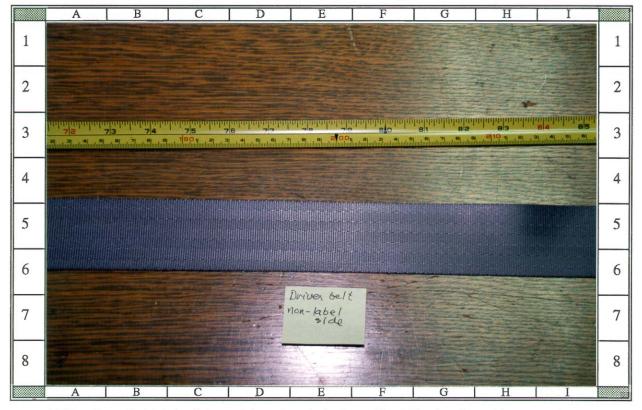
#100: Case Vehicle's driver side safety belt (i.e., 7 of 7) showing side away from a restrained driver; NOTE: no evidence of loading

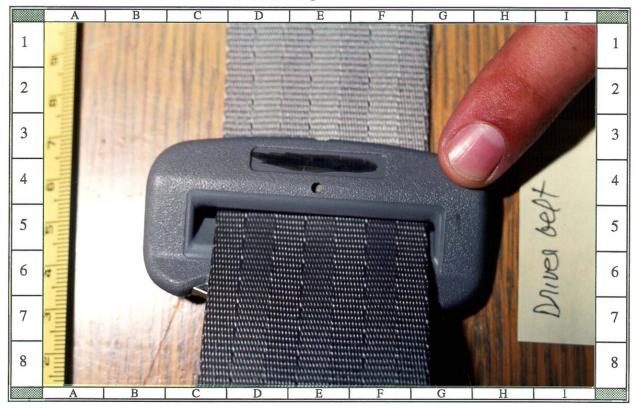
#104: Latch plate adjuster from Case Vehicle's driver side safety belt showing adjuster's side that would be toward a restrained driver; NOTE: no evidence of loading

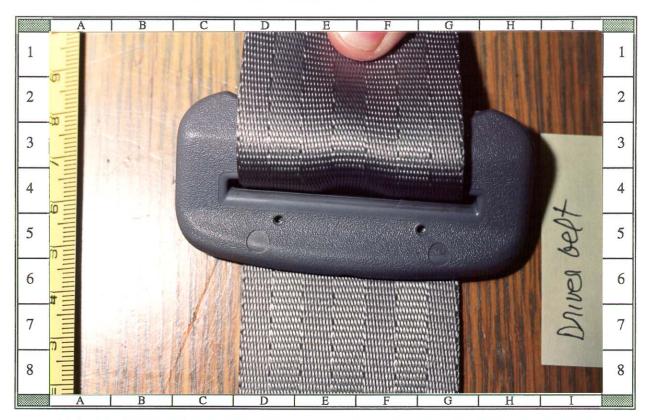
#105: Latch plate adjuster from Case Vehicle's driver side safety belt showing adjuster's side that would be away a restrained driver; NOTE: no evidence of loading

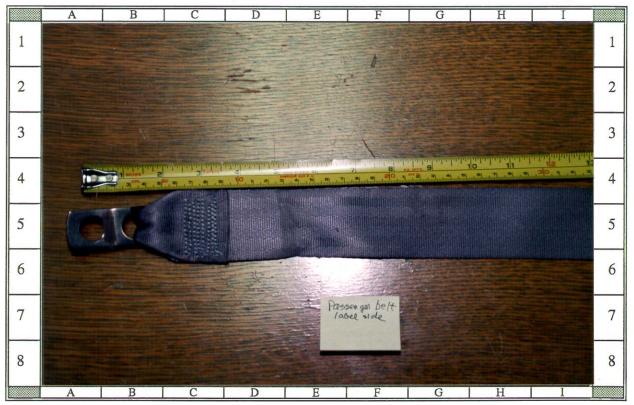
#106: Case Vehicle's right front safety belt (i.e., 1 of 7) showing side toward a restrained passenger and right floor anchorage attachment

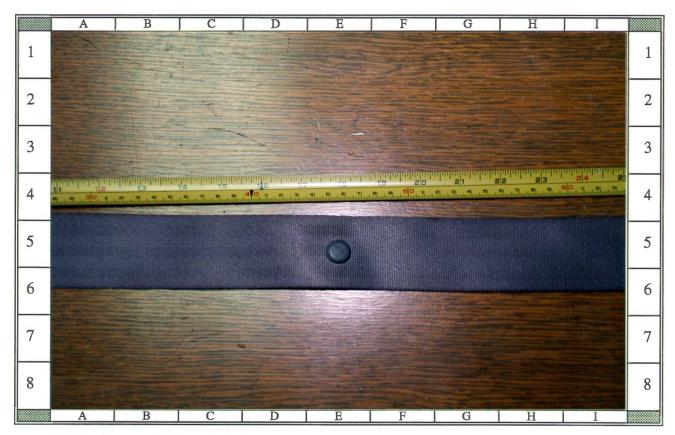
#107: Case Vehicle's right front safety belt (i.e., 2 of 7) showing side toward a restrained passenger; NOTE: no evidence of loading

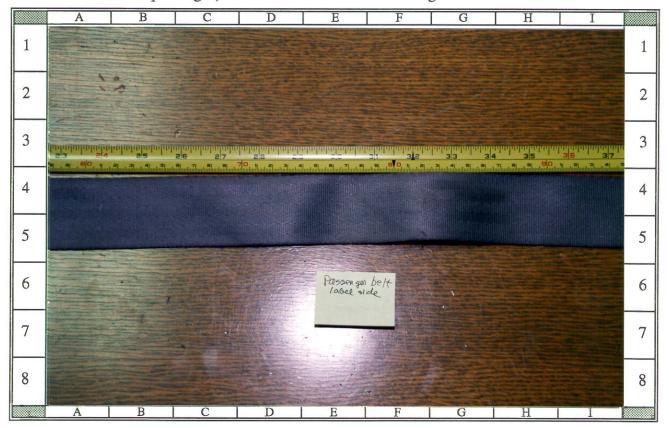
#108: Case Vehicle's right front safety belt (i.e., 3 of 7) showing side toward a restrained passenger; NOTE: no evidence of loading

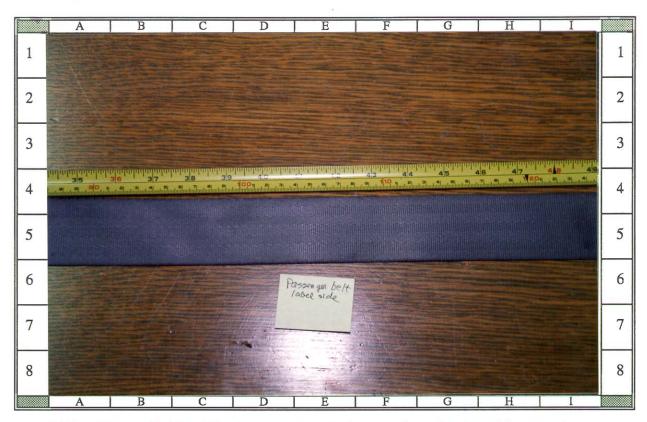
#109: Case Vehicle's right front safety belt (i.e., 4 of 7) showing side toward a restrained passenger; NOTE: no evidence of loading

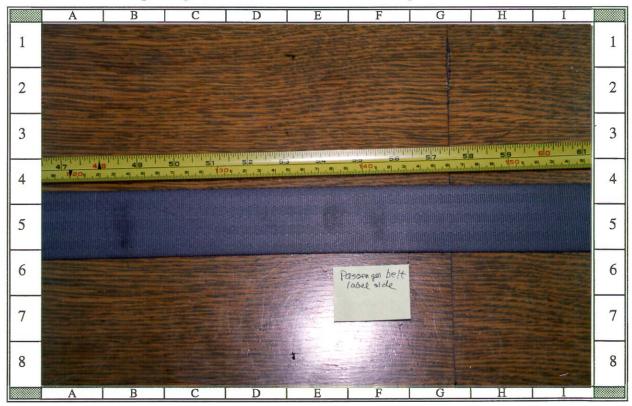
#110: Case Vehicle's right front safety belt (i.e., 5 of 7) showing side toward a restrained passenger; NOTE: possible greasy prints but no evidence of loading

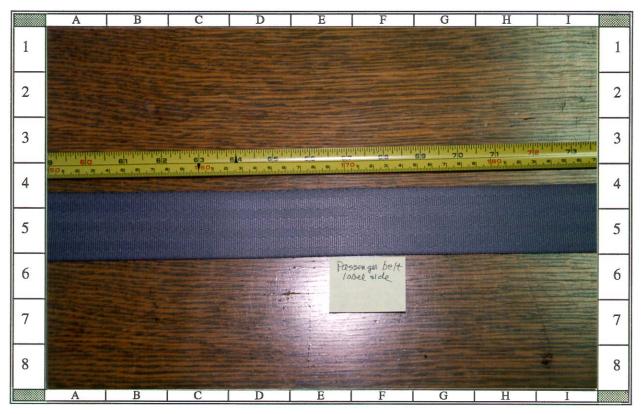
#111: Case Vehicle's right front safety belt (i.e., 6 of 7) showing side toward a restrained passenger; NOTE: no evidence of loading

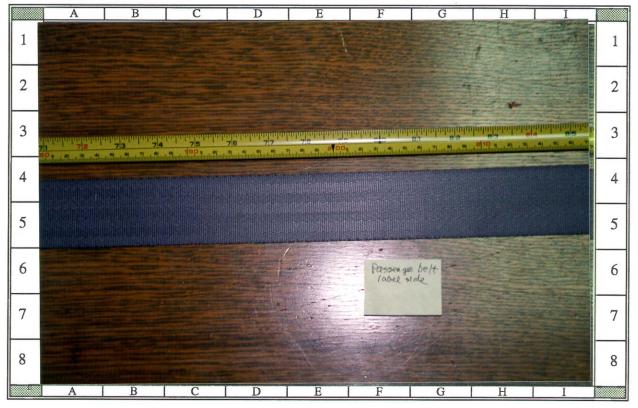
#112: Case Vehicle's right front safety belt (i.e., 7 of 7) showing side toward a restrained passenger; NOTE: no evidence of loading

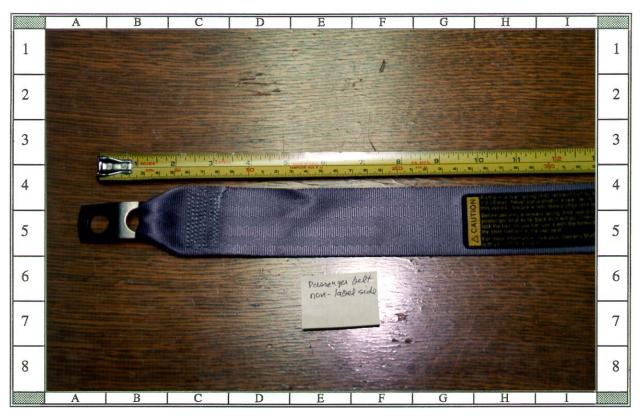
#113: Case Vehicle's right front safety belt (i.e., 1 of 7) showing side away from a restrained passenger and right floor anchorage attachment

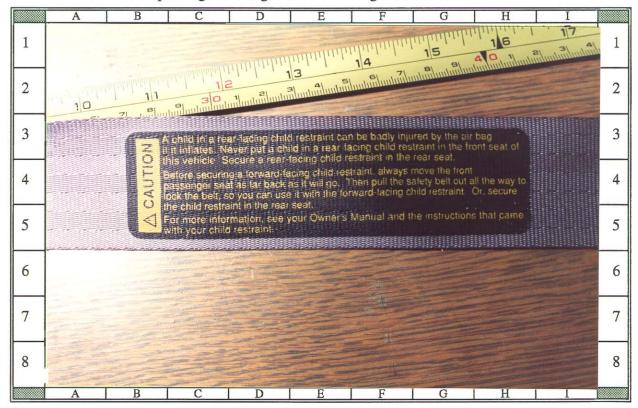
#114: Close-up of imprinted CAUTION sticker on Case Vehicle's right front safety belt overlapping 1st and 2nd 7ths of belt that would be toward a restrained passenger

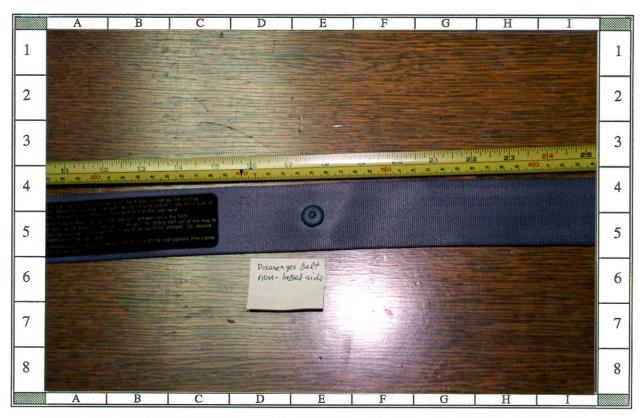
#115: Case Vehicle's right front safety belt (i.e., 2 of 7) showing side away from a restrained passenger; NOTE: no evidence of loading

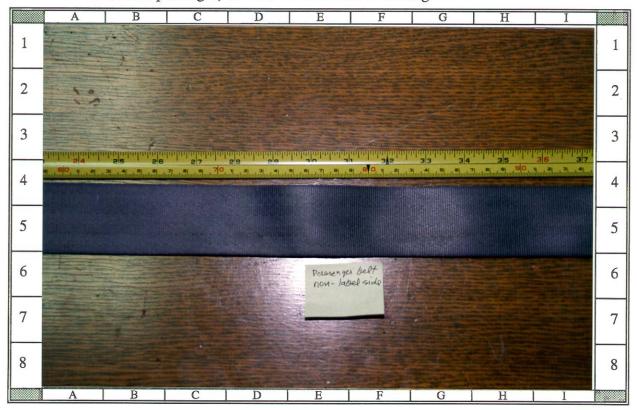
#116: Case Vehicle's right front safety belt (i.e., 3 of 7) showing side away from a restrained passenger; NOTE: no evidence of loading

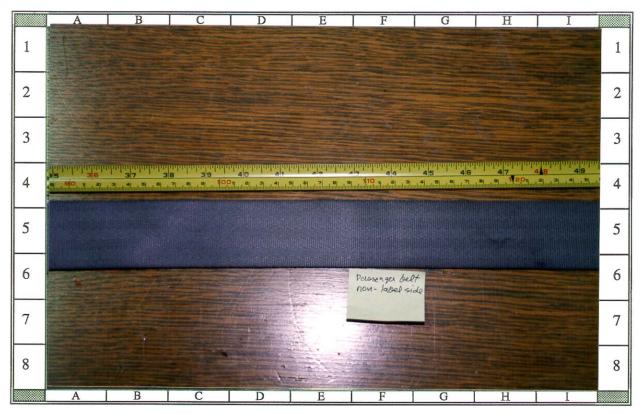
#117: Case Vehicle's right front safety belt (i.e., 4 of 7) showing side away from a restrained passenger; NOTE: grease smears but no evidence of loading

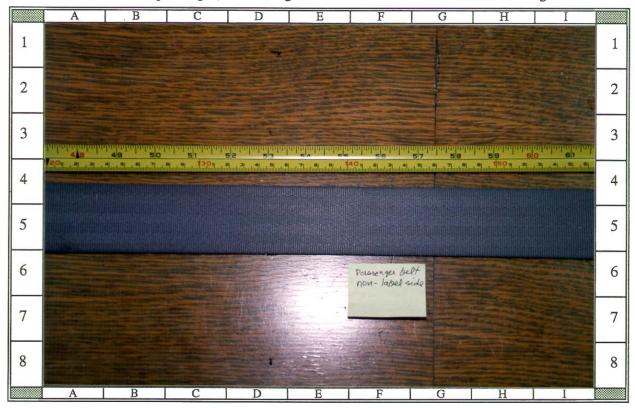
#118: Case Vehicle's right front safety belt (i.e., 5 of 7) showing side away from a restrained passenger; NOTE: no evidence of loading
